From: Stephen Best
To: Jake Sherman; Libby Landers; brendon.norton@flocksafety.com; Flock Safety
Cc: Eligio Lara; Daniel Cohen; Michael Balcorta; Stephen Best; Tee Jane Teh
Subject: FW: Flock Search SMPD24-0003249
Date: Tuesday, March 12, 2024 11:15:31 AM
Attachments: image003.png
image001.png
image002.png
image006.png
Flock Search SMPD24-0003249.zip

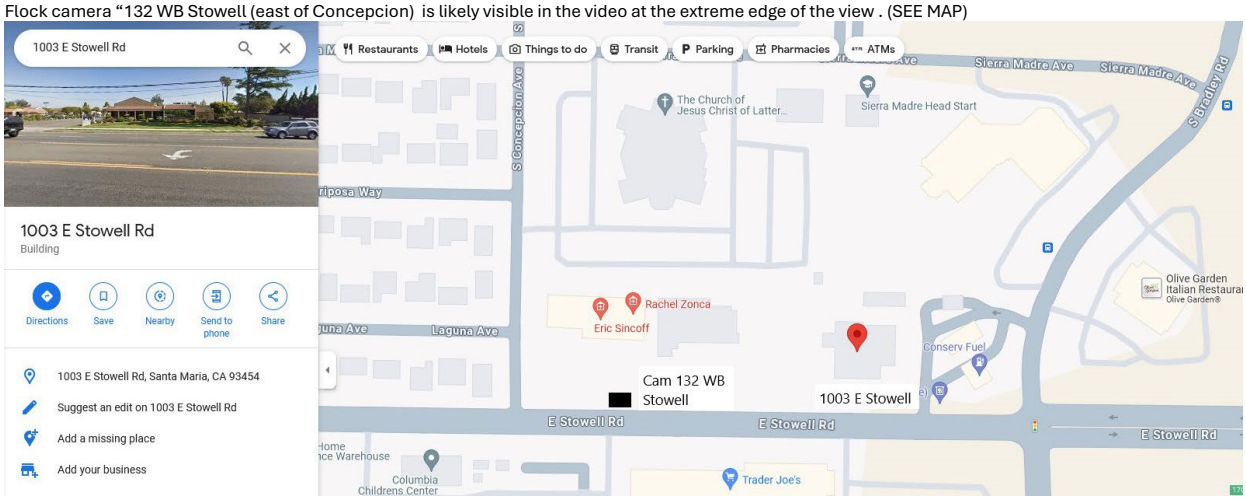
Flock camera "132 WB Stowell (east of Concepcion) is likely visible in the video at the extreme edge of the view . (SEE MAP)

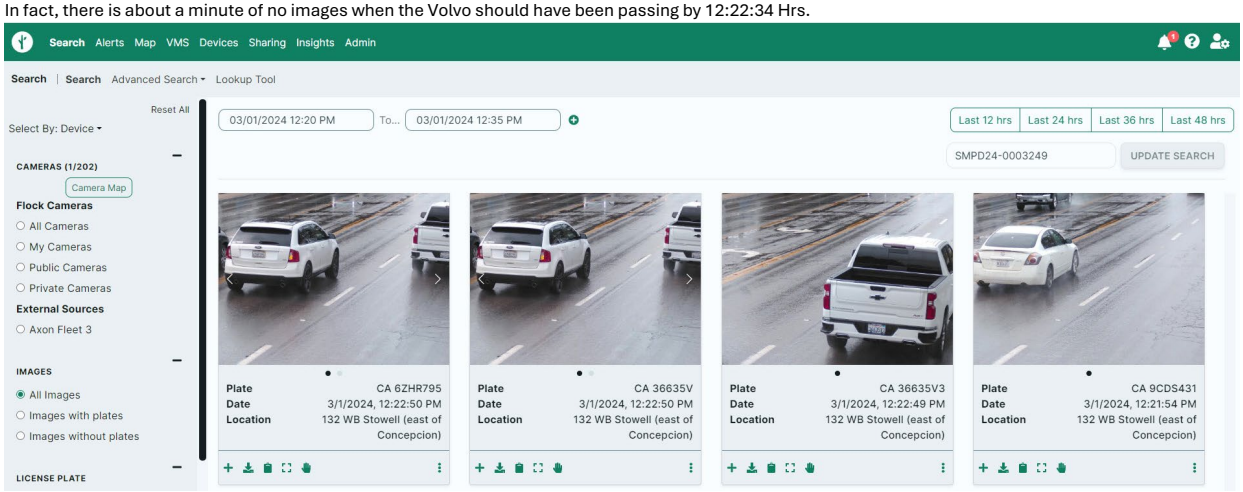
I searched just cam 132 for 03-01-24 from 1220-1230 Hrs. It got 110 results but not the white Volvo station wagon.
In fact, there is about a minute of no images when the Volvo should have been passing by 12:22:34 Hrs.

So again, flock completely missed our suspect vehicle leaving the scene of the crime and passing a Flock camera which was within 100 yards of the crime.

Support at Flock Safety....please scheduled maintenance on cam "132 WB Stowell (E of Concepcion) to ensure it is working property.

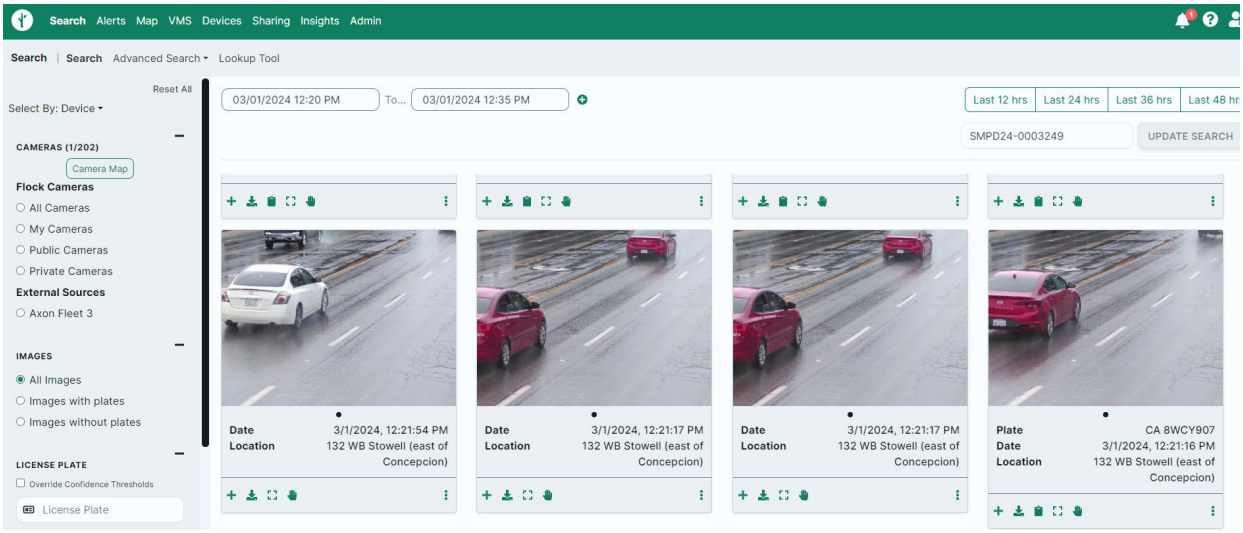
I confirmed my time calculations are correct by locating two red cars on video at 12:25:56 vid time, 12:21:17 Hrs Flock time

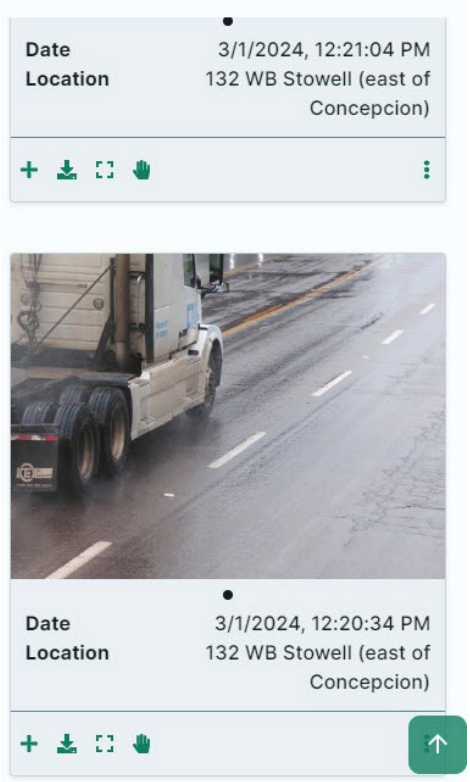
Date 3/1/2024, 12:21:04 PM
Location 132 WB Stowell (east of Concepcion)
Date 3/1/2024, 12:20:34 PM
Location 132 WB Stowell (east of Concepcion)

And a big rig at 12:25:14 Hrs vid time 12:20:34 Hrs Flock time

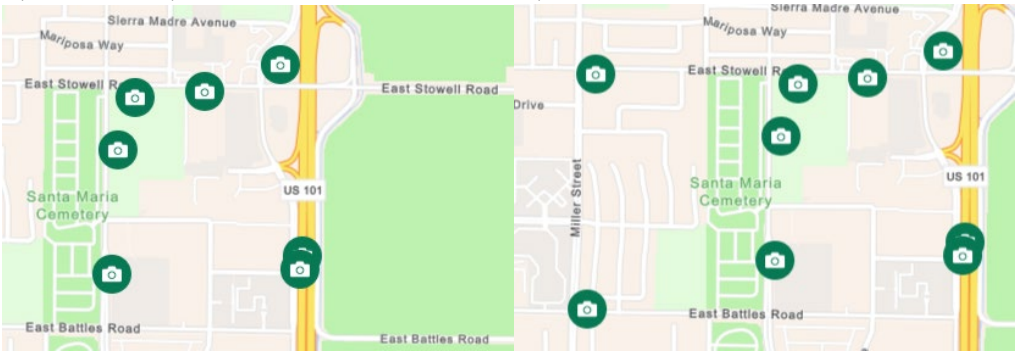
Expanded out the map twice more with same time frame and white parameter still no match

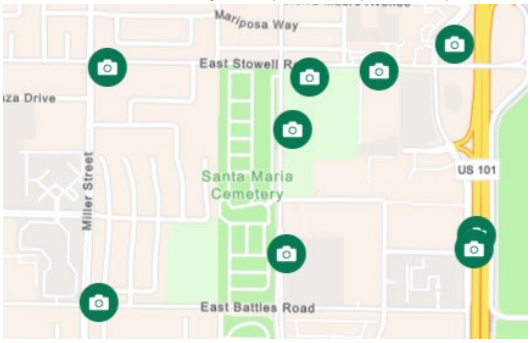
I did a Flock search utilizing this expanded map with the parameters of white, hatchback and wagon could not find a match from 0830-1330.
